TECHNICAL EVALUATION OF PEDESTRIAN FACILITIES ALONG THE PALEMBANG LRT LINE

Tri Mei Yuli^{1*}, Betty Susanti², Melawaty Agustien³

^{1,2,3} Program Studi Magister Teknik Sipil Fakultas Teknik, Universitas Sriwijaya

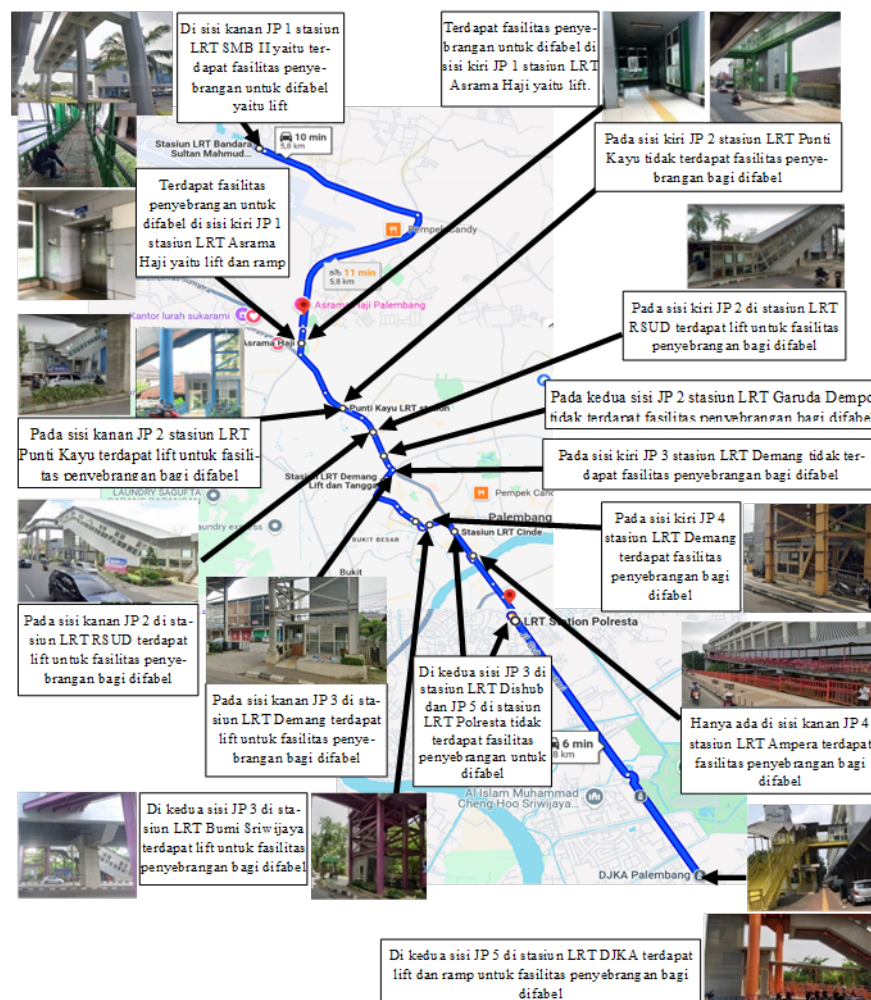
a. **Connectivity aspects,** (A1-A3) have met the JP (pedestrian path) technical standard criteria, on average all JPs are connected to more than 2 arterial roads (A1); all JPs are connected to public transportation nodes (A2) namely feeders, LRT, and transmusi; There are JPOs (Pedestrian Bridges), with a width of 100 cm on both sides of the Pedestrian path but have a considerable distance between one JPO (Pedestrian Bridge) and another JPO. The most JPOs are on the left side of JP 2 totaling 5 JPOs (A3) and the availability of crossing facilities for the disabled, available crossings for the disabled and there are signs and have clear boundaries (Table 4) (Mardiana et al., 2019) . Meanwhile, the existing conditions in the aspect of connectivity with the observed indicators are code A4, namely the availability of crossing facilities for the disabled complete with signs for the disabled (Figure 1).

Existing conditions in the aspect of connectivity with the observed indicator A4, namely regarding the availability of crossing facilities for the disabled.
