## IDENTIFICATION OF ARCHITECTURAL ELEMENTS IN THE OLD TEUNGKU MOSQUE IN PUCOK KRUENG DISTRICT. PIDIE JAYA

<sup>1,2,3</sup> Department of Architecture, Faculty of Engineering, Universitas Malikussaleh, Lhokseumawe, Indonesia

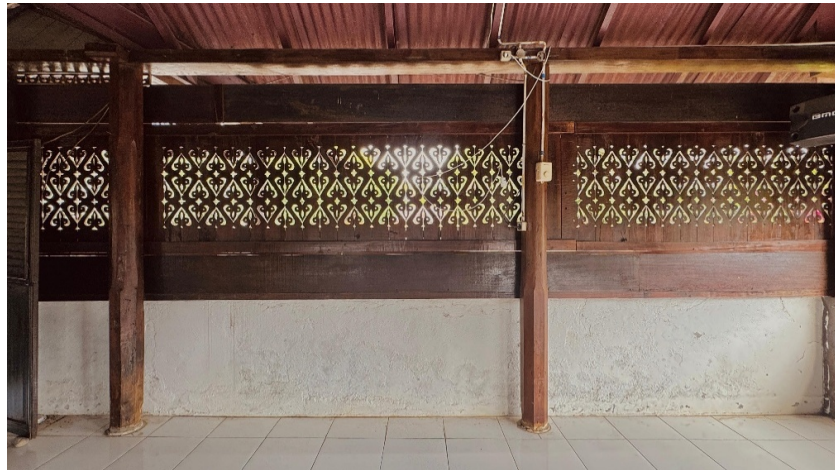
**Image 3.** Wall composition with solid base, timber panels, and perforated ornament

The observed wall system is layered. The lower section uses a stronger and heavier material such as stone, masonry, or plastered wall treatment. This base provides durability, resistance to moisture, and physical protection. The upper section uses timber and carved wooden panels that create a lighter visual expression. This combination is significant because it brings together the need for structural and environmental durability with the preservation of traditional visual character.

The wall height and repeated bay arrangement follow the rhythm of the timber columns. This creates an ordered composition and prevents the wall from appearing as a single heavy mass. The carved upper panels enrich the wall surface while supporting ventilation. The pattern of the wall therefore demonstrates how a traditional building can combine enclosure, airflow, ornament, and identity in one architectural system.

The 2016 earthquake affected parts of the wall, especially some masonry and timber components. The repairs made after the damage are important for continuing the use of the mosque, but future maintenance should be sensitive to the original wall proportion and craft details. The carved wooden panels should be prioritized for documentation and conservation because they carry both functional and aesthetic value.

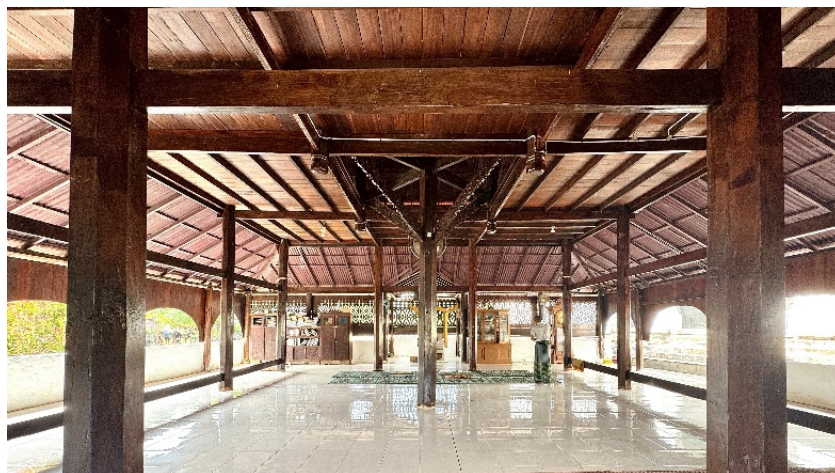
**Image 4.** Timber columns and upper structural rhythm in the prayer hall

Columns are the main vertical structural elements of the mosque. They carry roof loads, transfer loads downward, and maintain the stability of the prayer hall. The timber columns also organize the interior space without forming closed rooms. This allows the prayer hall to remain open while still expressing a clear structural order.

Field measurement indicates a hierarchy of columns. A central or dominant support has a larger diameter, while surrounding columns and perimeter supports have smaller dimensions. This hierarchy suggests different structural roles in supporting the tiered roof. The central support becomes not only a technical element but also a visual marker in the prayer hall. The surrounding columns create rhythm and help define the spatial grid.

The use of timber as the main column material reflects traditional Acehnese construction knowledge and local material culture. Timber gives warmth to the interior and produces a strong historical impression. The visible connection between columns, beams, and roof structure also allows users to read how the building stands. This readability is a major heritage value because it reveals the construction logic of the old mosque.

The earthquake of 2016 reportedly caused inclination in some columns. This condition shows that structural conservation is essential. Repair work should not replace the timber character with visually incompatible materials unless required by safety considerations. Even when reinforcement is needed, the original rhythm, proportion, and visible timber character should be maintained as far as possible.
