STUDY OF THE IMPACT OF TIDAL SAND MINING ON THE WATER QUALITY OF THE KAPUAS RIVER

U.M. Hapipin¹, Rossie Wiedya Nusantara², Aji Ali Akbar³

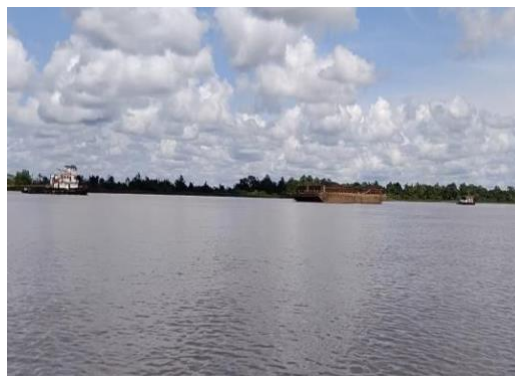
Figure 0-1. Activities Along the Kapuas River at the Research Location

The Kapuas River located at the research location, apart from being a water source for the community, is also used as a transportation route, both for public transportation and for transportation of industrial needs such as transportation of mining materials, plantations, fuel and others, as seen in Figure 4-1.
